Failure Analysis of a Kaplan Turbine Blade in Iraq's Haditha Hydropower Plant

Abstract. Kaplan turbines are widely used in low-water-head and large-capacity hydropower plants. The design of such systems is based on long-term performance. Nevertheless, many failures are reported in the industry, which lead to economic losses for the purpose of major repairs or replacement of a part of the system. Therefore, it is very important to know the failures, their causes, and finally provide useful solutions for their prevention or early treatment. In the present article, the authors focused on the failure detection of a Kaplan turbine blade in an Iraqi hydropower plant, and then, determined the direction of their future research. Quantometric test, tensile test, compression test, microhardness test, metallographic examination and study of the damaged surface were conducted from damaged runner blade. It was revealed that the raw material for manufacturing runner blade of Kaplan turbine was 304 stainless steel by employing cold drawing or rolling process. In addition, annealing treatment has also been done. In addition, it was found that the predominant damage in the studied part was severe

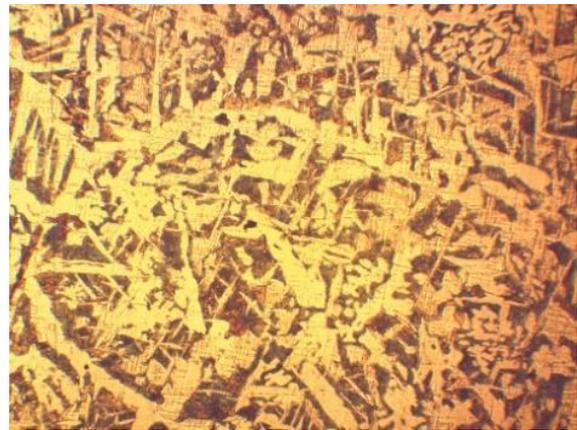
Figure 6 presents the Optic Microscope (OM) image of specimen with 10X magnification. From this Figure, the main phase is austenite. But there are numerous twins, which could be created by annealing or by rolling. In addition, parallel lines arose by the rolling during the technologic process.

Figure 6. The OM image of specimen with 10X magnification
Source: photo by the authors

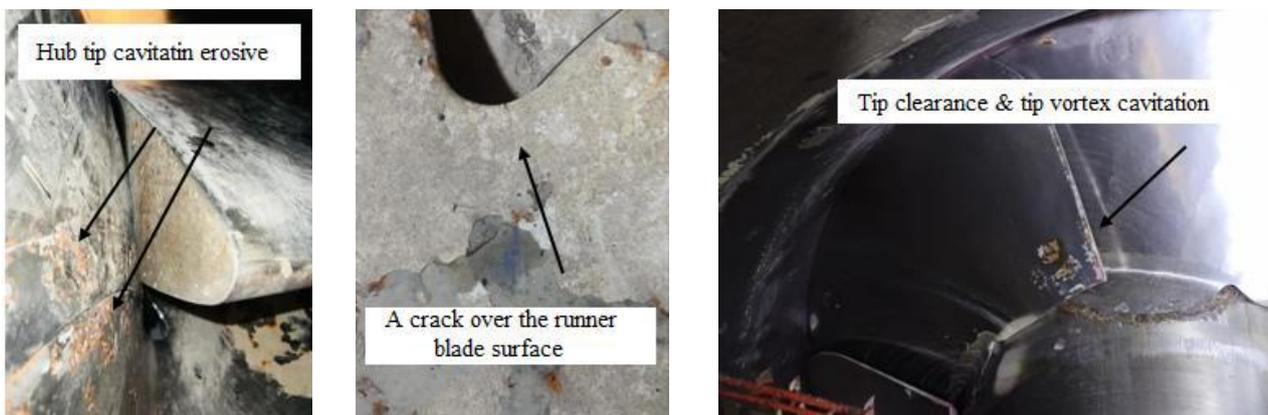
The results of examining the objective evidence on the damaged surfaces show that severe cavitation occurred due to very harsh working conditions, which resulted in high structural vibration due to dynamic loading, and finally, erosion damage of the runner blade occurred. Moreover, structural crack have been seen in the runner blades, and these

problems are exacerbated as long as the units are operating against their intended specifications. This condition resulted in damage to the runner blades in the Kaplan turbine of Haditha HPP, as shown in Figure 7. In addition to the above-mentioned damage, excessive off-design operation causes blade damage, wear in various turbine parts, and eventually fatigue damage. Figure 8 demonstrates an example of the structural damages that Haditha plant turbines suffered.

Figure 7. Cavitation and cracks of the Haditha HPP Kaplan turbine:
image courtesy of the Ministry of Electricity, Iraq
Source: photo by the authors

In the present research, a case study was conducted on the damaged part (runner blade) of Kaplan turbine in Haditha HPP from Iraq. After performing various tests and obtaining mechanical, material, and metallurgical properties of standard specimens, which are fabricated from damaged runner blade, it was proved that the raw material for manufacturing runner blade of Kaplan turbine was 304 stainless steel by employing cold drawing or rolling process. In addition, annealing treatment has also been done. To accurately determine the manufacturing steps, it is necessary to perform different tests and different thermal treatments on 304 stainless steel and compare the results with the data obtained from the damaged part. Furthermore, it was found that the predominant damage in the studied part was severe cavitation. In fact, cavitation is a phenomenon that occurs in a variety of turbomachinery applications and causes problems with those systems. Some of these downsides include damaging the components of the system, generating noise and vibration, and losing the turbine's efficiency over time. Thus, it is imperative to address the issue of cavitation to increase the life span of the equipment in addition to improving the system performance. However, for the high flow rate required by the Kaplan hydro turbine, which requires good cavitation erosion resistance, 304 stainless steel is the most suitable material for this type of application. Hence, the best solution is to strengthen this steel against cavitation. In summary, in their future research, the authors are looking for useful solutions (e.g., coating) to improve the properties of 304 stainless steel against cavitation, wear, and erosion phenomena.

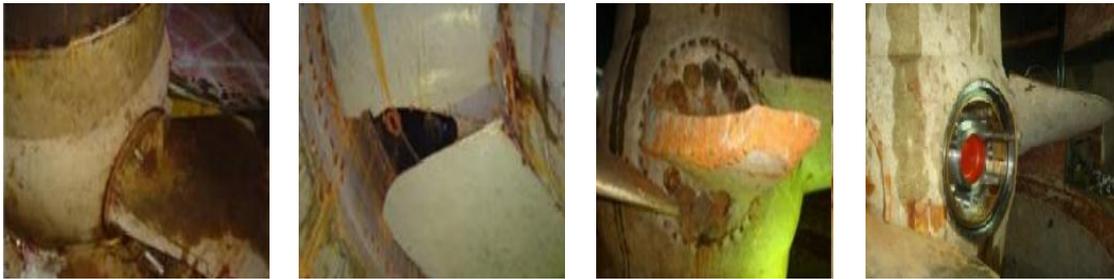
Figure 8. Damaged runner blades of the Haditha HPP Kaplan turbine:
image courtesy of the Ministry of Electricity, Iraq
Source : photo by the authors
