Research article / Научная статья

Technical Solution to Decrease Cavitation Effects in the Kaplan Turbine Blade

Mohammed Ridha W. Khalid^{ORCID}, Kazem Reza Kashyzadeh^{ORCID}, Siamak Ghorbani^{ORCID}✉

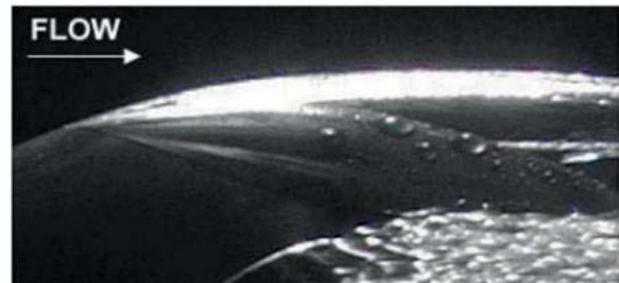
Figure 3. Lead edge cavitation
Source: Mohamed F., Francois A. [21]

to cause significant erosive damage. From Figure 3, this kind of cavitation is distinguished by a partial vapor cavity that separates from a lifting body's leading edge and spreads downriver [21]. Also, due to operating at a higher head than the machine's design head, it manifests as a connected cavity on the suction side of the runner blades [11]. This is a very frequent and complex type of cavitation, and depending on the hydrodynamic circumstances, it can exhibit several regimes.

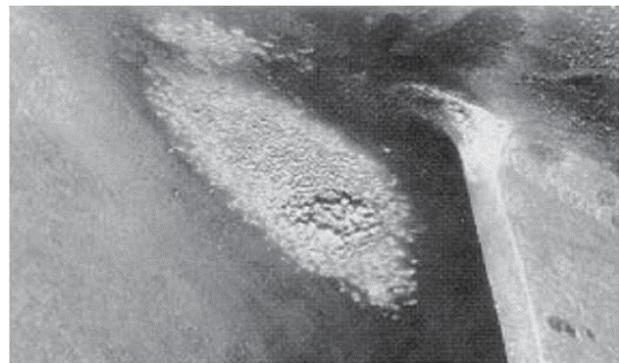
Figure 4. Hub vortex cavitation
Source: Sezen S., Atlar M. [22]

The high swirl of the flow in the blade slipstream close to the rotational axis is where the wasted energy is first used up. This swirl will cause a pressure drop in relation to ambient pressure, which will produce an unfavorable drag force on the blade [22]. Also, when the swirl is high, axial thrust will not be produced by the energy transfer to the fluid at the hub, and turbulence will be dispersed by mixing. In addition, hub vortex cavitation, as shown in Figure 4, has a sizable cavity.

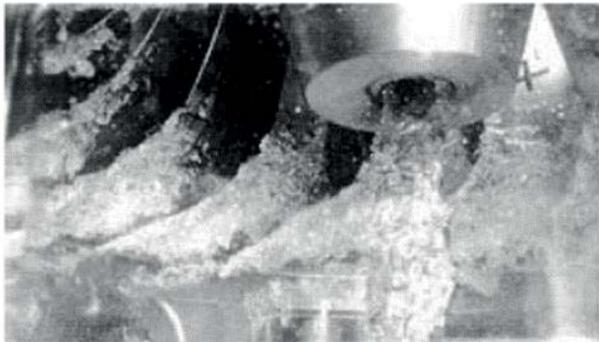
Figure 5. Travelling bubble cavitation
Source: Jani D.B. et al. [24]

In this type of cavitation, the cavitation nuclei, also known as microbubbles, travel through the flow field until they reach the lower pressure zones, where they transform into large macroscopic cavitation bubbles before collapsing at pressure recovery zones. According to Figure 5, the interactions between the produced bubbles and nearby walls or other bubbles often result in complicated shapes for the bubbles [24].
