### Case study on structural health assessment for existing reinforced concrete building

## Оценка состояния конструкций существующего железобетонного здания и способы его укрепления

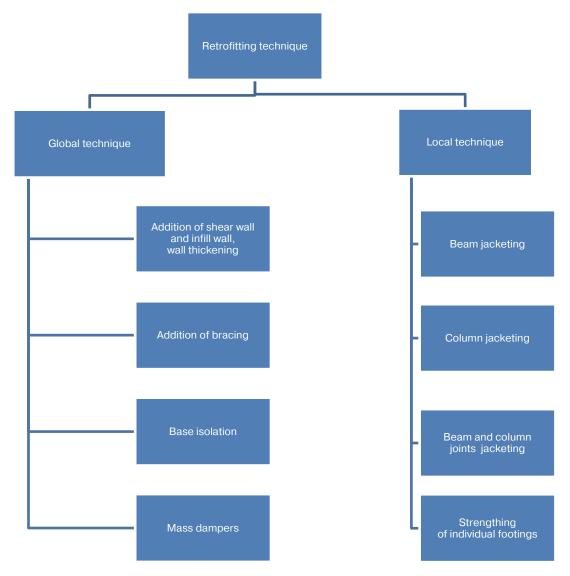
Figure 4. Different techniques of retrofitting [6]

- increase in dead load and chances of erosion are high;
- high installation cost;
- if any indication of corrosion in the reinforcement, this technique is not useable;
- bonding between concrete and steel plates may not be proper;
- the production of dust causes health hazards to the public (Figure 4).

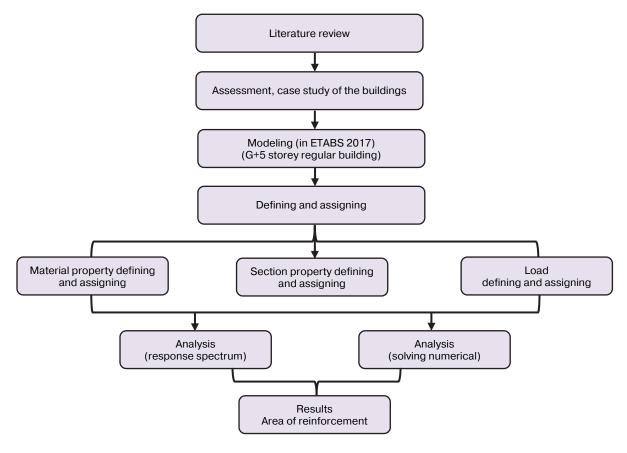
Figure 5. Methodology flowchart

The six-storied existing commercial building including 2 more stories after previous design was modelled on ETABS 2017 with load patterns and cases as per IS 875 and IS1893:2016 for a building with commercial purposes for the study (Tables 1–3). Structure analysis of the structure was carried out using ETABS 2017. Also, three dimensional models were prepared and the existing building was designed as per the client requirements. The deficient in reinforcement was calculated for columns that need to be reinforced. Over stressed (o/s) columns were used for the design of RC jacketing whereas columns with reinforcement deficient were used in design of CFRP. Furthermore IS 15988<sup>1</sup>; 2013 code was used for the design of RC column jacketing and ACI 440.2R-08/ACI-318-05<sup>2</sup> was used design of CFRP for strengthening of RCC column due to deficiency in longitudinal steel reinforcement. The methodology we used can be shown in Figure 5.

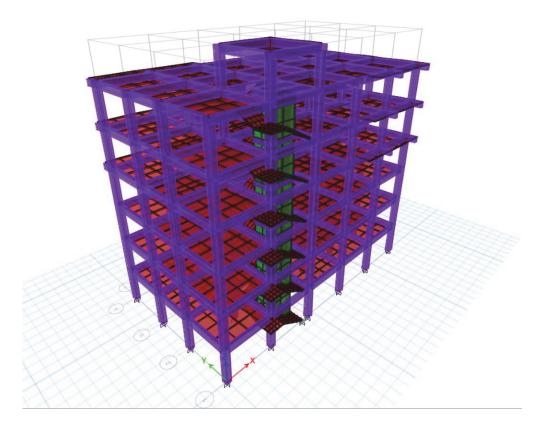
**Figure 6.** 3D modelling of building in ETABS

The 3D model diagram of building in ETABS can be seen in Figure 6 whereas the plan of first floor and the layout of column is shown in Figures 7 and 8 respectively.

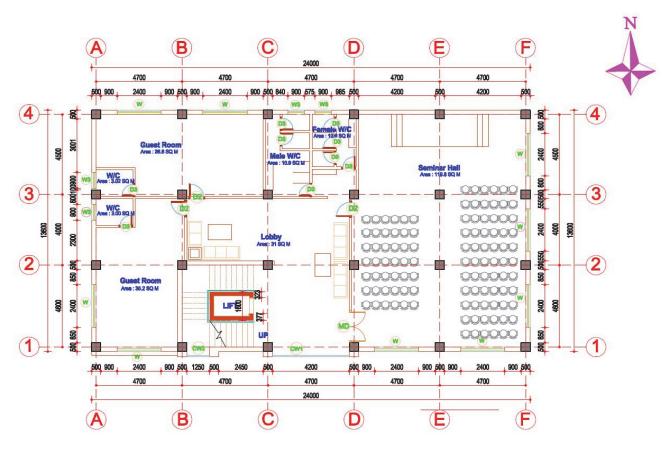
Figure 7. First floor, plan of building

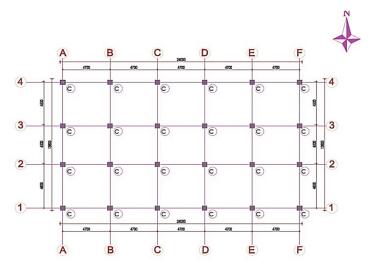
Figure 8. Column layout of building

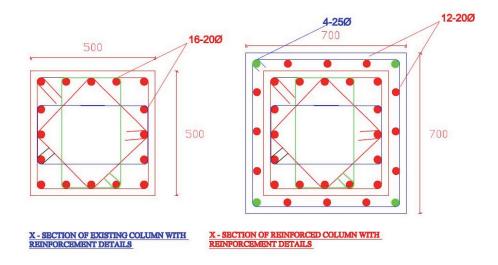
Figure 9. X-section of existing and reinforced column with reinforcement details

Thus, we provide  $4-25\emptyset$  and  $12-20\emptyset$ , i.e. 5733.416 mm<sup>2</sup> for the new jacketed section of  $700\times700$  mm.

The outcomes of all the columns which required retrofitting either by RC jacketing or CFRP jackets from the above design example are illustrate in Tables 4, 5 and Figure 9.
