DOI: 10.22363/1815-5235-2024-20-2-120-133
UDC 699.841
EDN: JNAYFF

Seismic Fragility Analysis of Existing Old Newari Brick Masonry Building in Pokhara Valley

Krishna Chapagain^{ID}, Hemchandra Chaulagain^{ID}✉

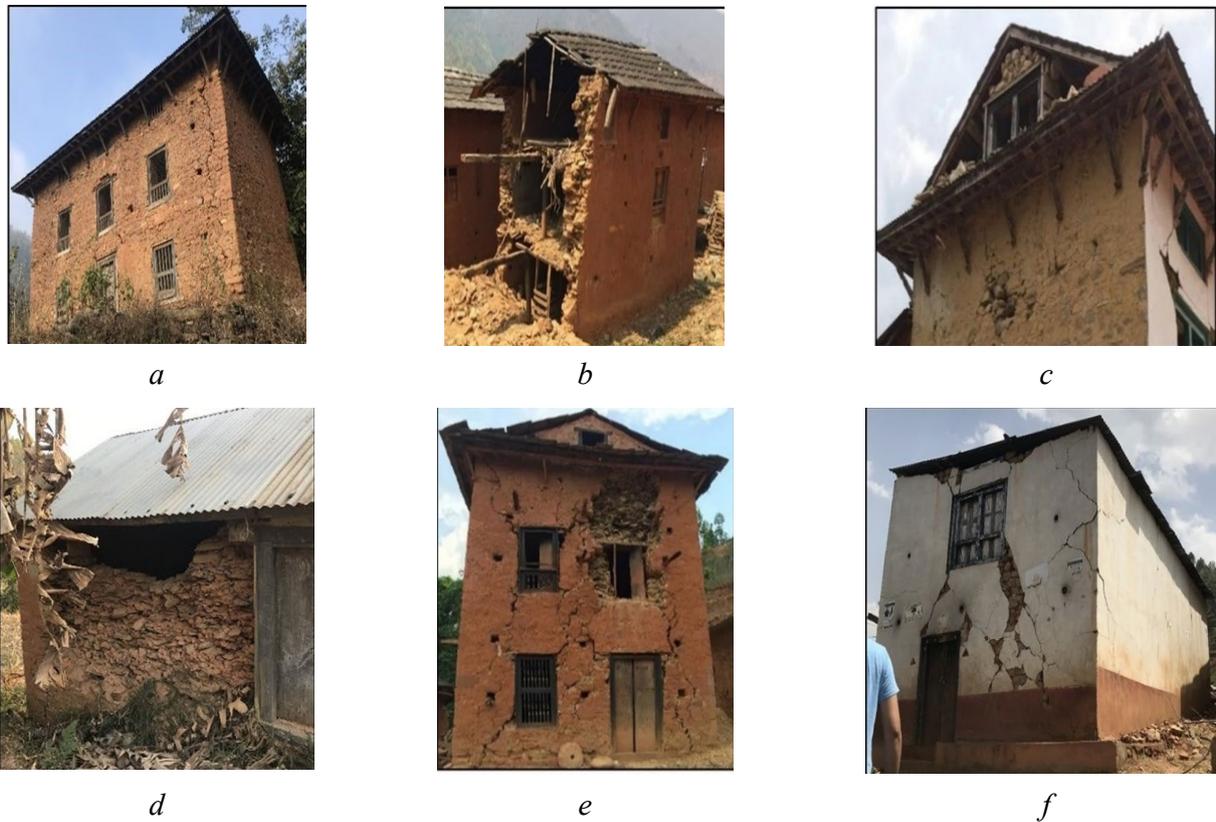
Figure 1. Failure mode in masonry building during earthquake:
a — separation of short wall at cross section; *b* — complete collapse of short wall; *c* — collapse of gable wall;
d — out of plane bulging; *e* — in plane damage with opening; *f* — shear damage

Most of the historic, administrative, and residential building structures in Nepal are based on masonry construction. To date, more than 60 % of buildings in Nepal are masonry, which have heavy mass and low compressive strength, and these structures are normally up to four stories tall. They have a flexible diaphragm system both in the roof and floor levels. Basically, masonry structures are built with mortar and masonry units. The mortar is made with lime-cement, clay, and bitumen, while mud, stone, and fire clay are used as masonry units. However, the majority of the masonry buildings in Nepal are constructed without adopting proper engineering guidelines. In past seismic events, the masonry structures have failed due to inadequate brick units, poor quality of mortar, irregularities in plane and vertical direction, inadequate load-bearing walls, lack of vertical confinement, weak bottom storeys, wall openings, improper section and dimension, wall connections, etc. [1]. In fact, unreinforced masonry buildings are more vulnerable to earthquakes due to their heavy mass, insufficient deformation capacity, and lack of integrity between the structural elements [2]. These types of structures have a brittle failure mode during earthquakes (see Figure 1).

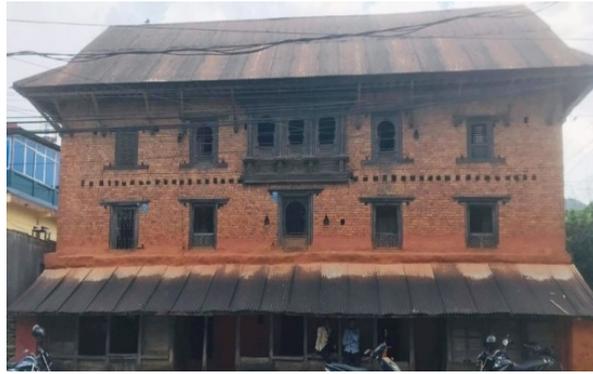
Figure 2. Old Newari building
 Source: Photo by K. Chapagain, H. Chaulagain

The prototype building structure is a traditional building in the locality that was constructed in the 17th century using original local technology. Most old Newari buildings in the area have traditional architecture. The building is three to four stories high with a floor height ranging from 1.8 to 2.3 meters and a larger opening ratio in the lower stories. The building typically has a simple rectangular floor plan with a breadth of over 6 meters and a length between 10 to 16 meters. The substructure uses shallow foundation with stones, and the superstructure is built with locally available clay burnt brick and mud mortar. The design is supported by three walls, two external walls, and one spine wall in the middle. In the upper story, the spine wall is sometimes replaced by a timber column frame system for creating a bigger continuous space. Wood joists uphold the floors and rooftop, over which wooden sheets or boards with a thick layer of mud topping are applied. The rooftop is typically doubly pitched and covered with traditional stone in the past, but nowadays, they are replaced by CGI sheets to make it waterproof. The brick masonry wall's typical thickness is about 60 cm and consists of a bricklayer in mud mortar and timber planks and beams.

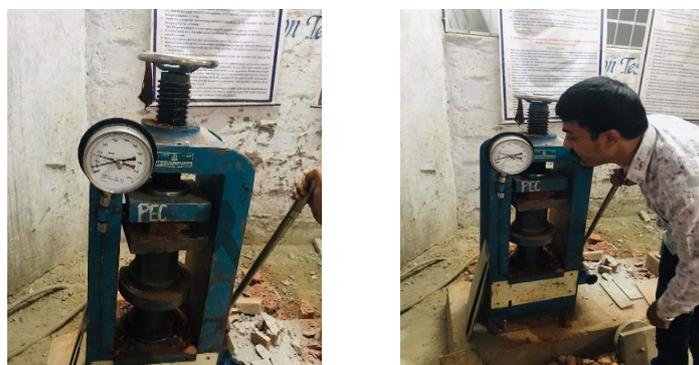
Figure 4. Testing of brick samples in lab

The old Newari building that exists today was constructed 265 years ago in 1814 B.S and is still being used as a residential space. Despite being exposed to various earthquakes in the past and recent times, the building remains in good usable condition. The masonry walls of the building are made of brick units constructed using local cohesive soil without the addition of any binding materials. In order to assess the strength of the bricks, a sample was taken from the building and tested using a Compression Testing Machine (CTM), and the results of this experiment are provided in Table 2. Additionally, Figure 4 depicts the testing process for the brick units.
